11 MISSION SUPPORT PERFORMANCE

14 ANOMALY SUMMARY

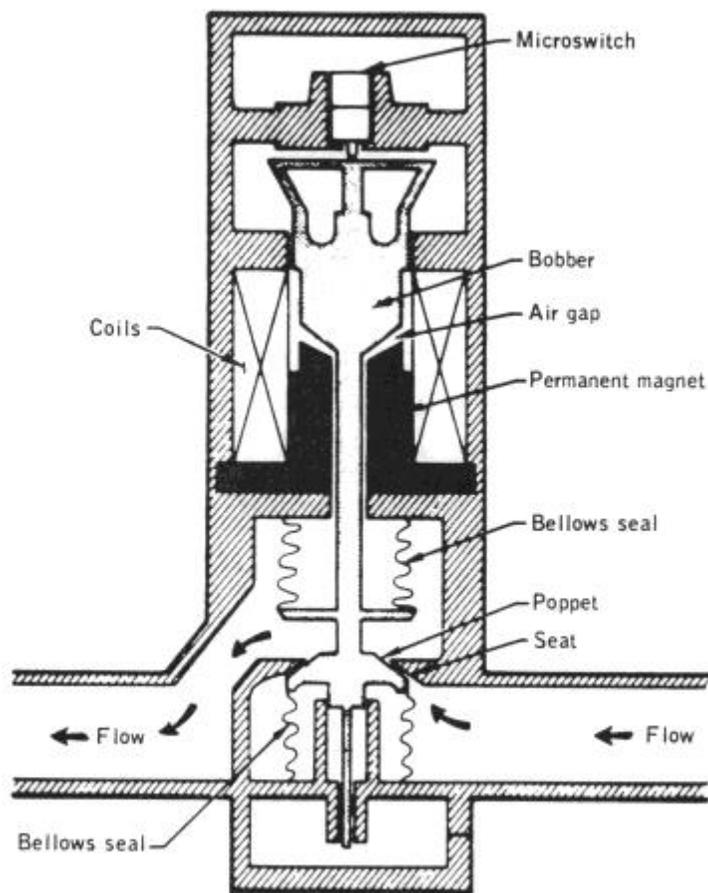
Figure 14-1.- Cross section of reaction control system isolation valve.

This type of valve (a magnetic latching valve, shown in **Fig. 14-1**) has, in previous missions, closed as a result of pyrotechnic shocks. Ground tests have shown that the valve will close at a shock level of approximately 80g sustained for 8 to 10 milliseconds. There were no indications of shock levels of the magnitude required to close the valve during launch.

Testing has shown that if a reversed voltage of 28 volts is applied to the valve, the latching voltage will drop to a point where the valve will no longer remain latched (magnet completely degaussed). In addition, at lower voltages with reversed polarity, the magnet would become partially degaussed.

During acceptance testing of one valve for command and service module 117, the latching voltage had changed from approximately 13 volts to 3 volts. Additional testing of the spacecraft 117 valve verified the low voltage condition. Additionally, the valve stroke was proper, thereby eliminating contamination as a possible cause of the problem. During the test, the valve was disconnected from spacecraft power (28 volts) and was being supplied power through a variable power supply (approximately 20 volts, maximum, applied to the valve). The valve was most likely subjected to a reversed polarity at a voltage level which would partially degauss the magnet. This may have been the cause of the valve closures during Apollo 15 launch phase.

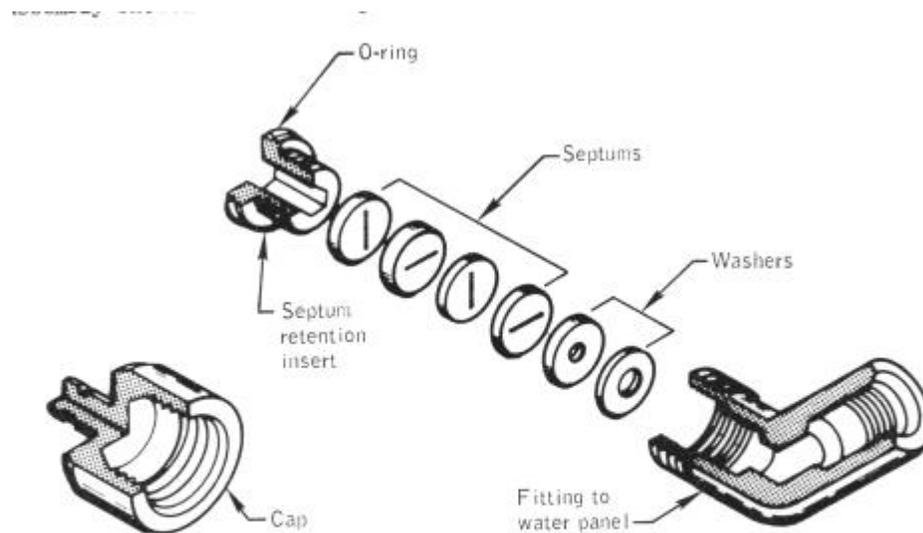
Figure 14-2.- Water panel chlorine injection port.

Minor leakage was noted from the chlorination injection port when the cap was removed to perform the prelaunch water chlorination. The cap was reinstalled and the leak ceased. A leak of approximately 1 quart in 20 minutes also was noted at the chlorine injection port as the crew removed the injection port cap for the third injection at about 61 hours. The crew tightened the septum retention insert (**Fig. 14-2**) and satisfactorily stopped the leakage. Leakage recurred at about 204 1/2 hours and was corrected.

Postflight inspection and dimensional checks of the injection port assembly showed that all components were within established tolerances.

However, when the insert was tightened in accordance with the drawing requirements, the resulting septum compression was apparently insufficient to prevent the insert from loosening as a result of "O-ring drag" when the cap was removed. This allowed water leakage past the relaxed septums.

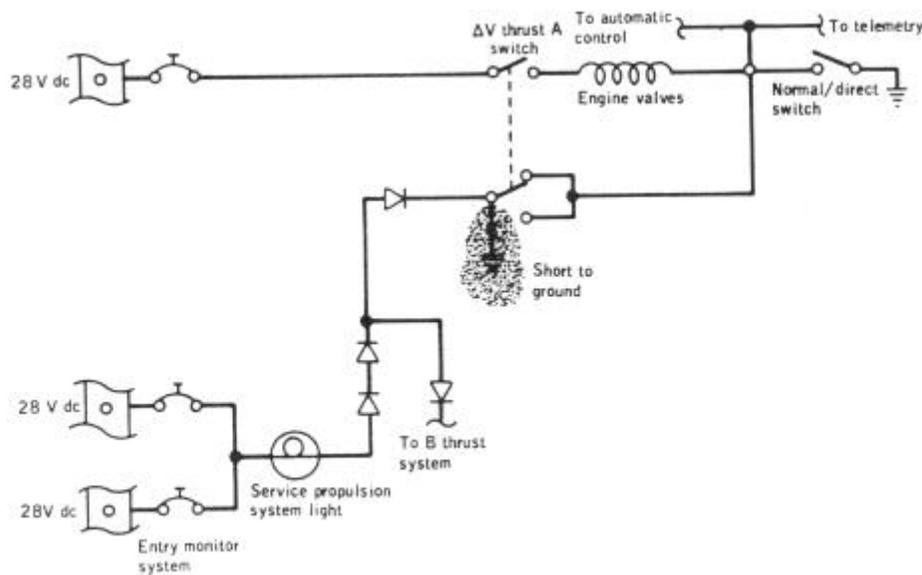
Figure 14-3.- Service propulsion system thrust light circuitry.

The service propulsion system thrust light located on the entry monitor system panel was illuminated shortly after transposition and docking with no engine firing command present. This light indicated the presence of a short to ground in the service propulsion system ignition circuitry. Ignition would have occurred if the engine had been armed.

The short was isolated to the system A delta-V thrust switch which was found to be intermittently shorted to ground (**Fig. 14-3**).

A test firing performed at 28:40:22 verified that the short existed on the ground side of the service propulsion system pilot valve solenoids.

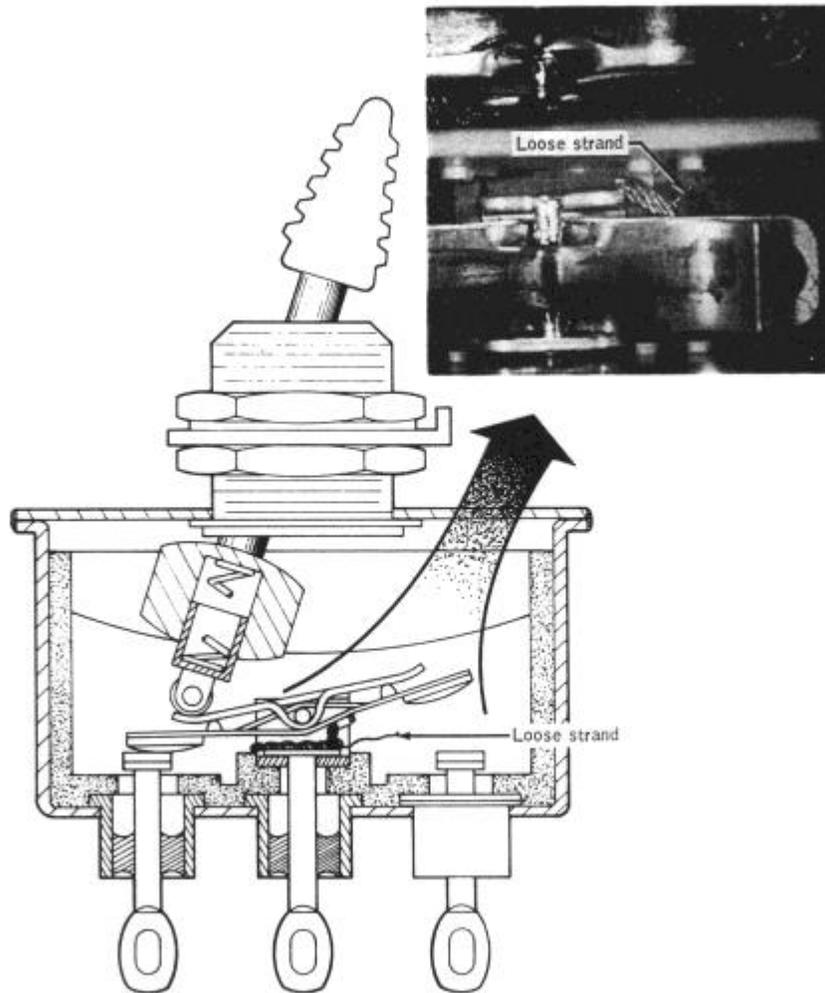
Figure 14-4.- Service propulsion system delta-V thrust switch.

The delta-V thrust switch (**Fig. 14-4**) was shorted to ground both before and after removal of panel 1 from the command module during postflight testing. After a change in panel position, the short-to-ground disappeared. The switch was then removed from the panel and X-rayed. The X-rays showed a wire strand extending from the braid strap which was thought to have caused the grounding problem. After switch dissection, an internal inspection verified that a strand extended from the braid strap; however, it did not appear to be long enough to cause a ground at any point within the switch (**Fig. 14-4**). The bracket assemblies (pivot brackets, pigtail braids, and movable contacts) and the plastic liner were removed from the switch. Microscopic examination revealed that a

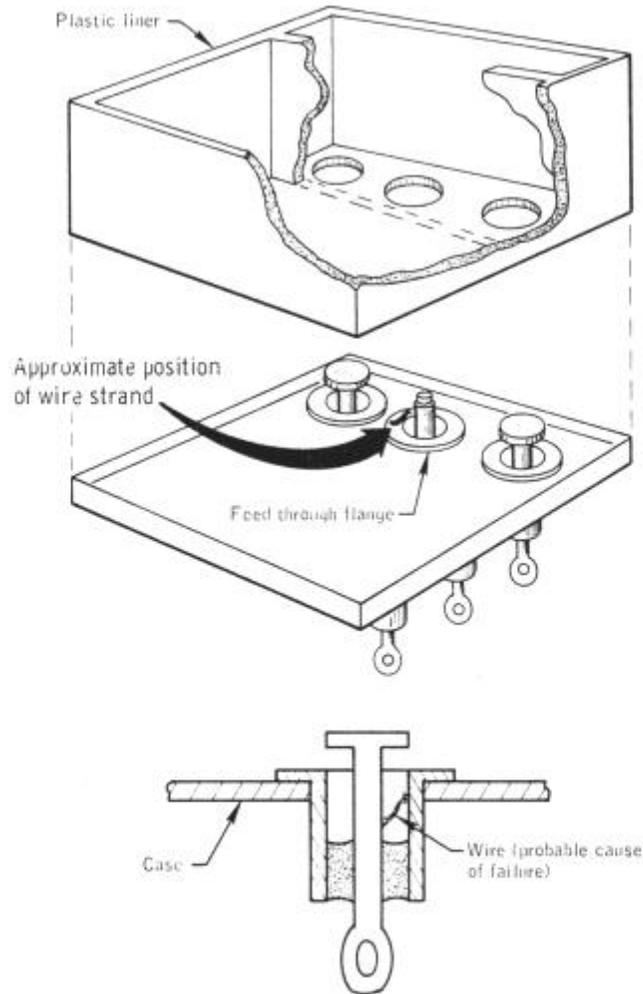
Figure 14-5.- Disassembled service propulsion system thrust switch.

wire strand (approximately 0.055 inch long) was present on the flange on terminal 2 (Fig. 14-5). The strand appeared to be attached, but was later moved quite easily.

The bottom of the plastic case liner was examined, and showed no evidence of a scratch or deformation conforming to the shape of the wire strand. A sample wire strand was placed on a feed-through flange of a scrap switch unit, and the plastic case liner was pressed on as would occur during normal switch assembly. When the scrap switch was disassembled an indentation in the plastic case liner was readily apparent. This test indicated that the strand could not have been trapped between the case liner and the flange surface; therefore, it is postulated that it might have been enclosed in the cavity of feed-through terminal 2 (Fig. 14-5). The maximum clearance between the interior of

the feed-through terminal wall and the terminal itself is 0.040 inch. A 0.055-inch-long wire strand could easily have bridged this distance, and yet is short enough to move quite freely within the feed-through terminal cavity. In fact, the strand subsequently fell into the cavity. Examination of the strand and cavity wall showed evidence of arcing. The strand could not be detected on the X-rays because that area was obscured by other poles in the switch.

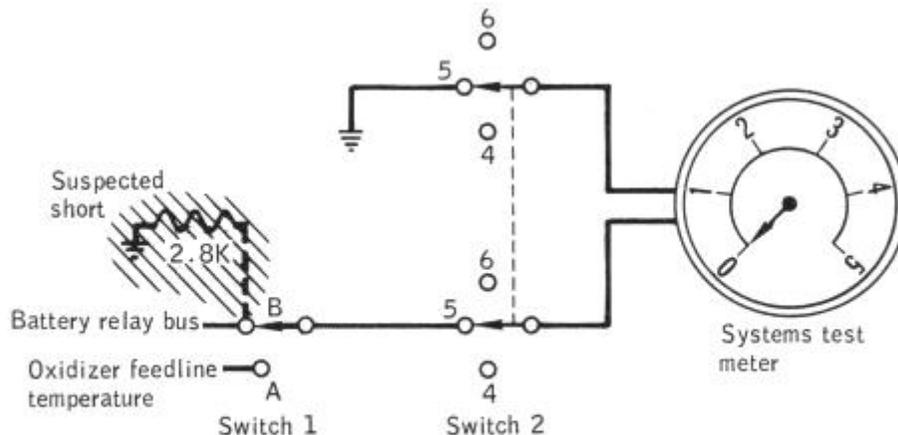
Figure 14-6.- Systems test meter switch.

At approximately 81-1/2 hours, the battery relay bus voltage telemetry measurement read 13.66 volts instead of the nominal 32 volts, as evidenced by battery bus voltage measurements. The crew verified that the same low voltage reading was present on the panel 101 systems test meter. When the crew moved the systems test meter switch, the reading returned to normal.

Postflight testing of the vehicle and all of the involved components revealed no anomalous condition which could have caused the problem but did isolate the problem to the instrumentation circuitry and verify that the functional operation of the bus was not impaired. Analysis indicates that the only way to duplicate the flight problem would be to connect a resistance of 2800 ohms from ground to the battery relay bus measurement circuit (**Fig. 14-6**). No resistance near this magnitude was measured during postflight testing. The most probable cause of the anomaly was that insulation resistance at the output terminal of the switch was lowered because of humidity.

This is the only time that a problem of this type has occurred during the Apollo Program and the probability of recurrence is considered to be very low. If the problem does occur again, other measurements are available for the determination of the battery relay bus voltage.

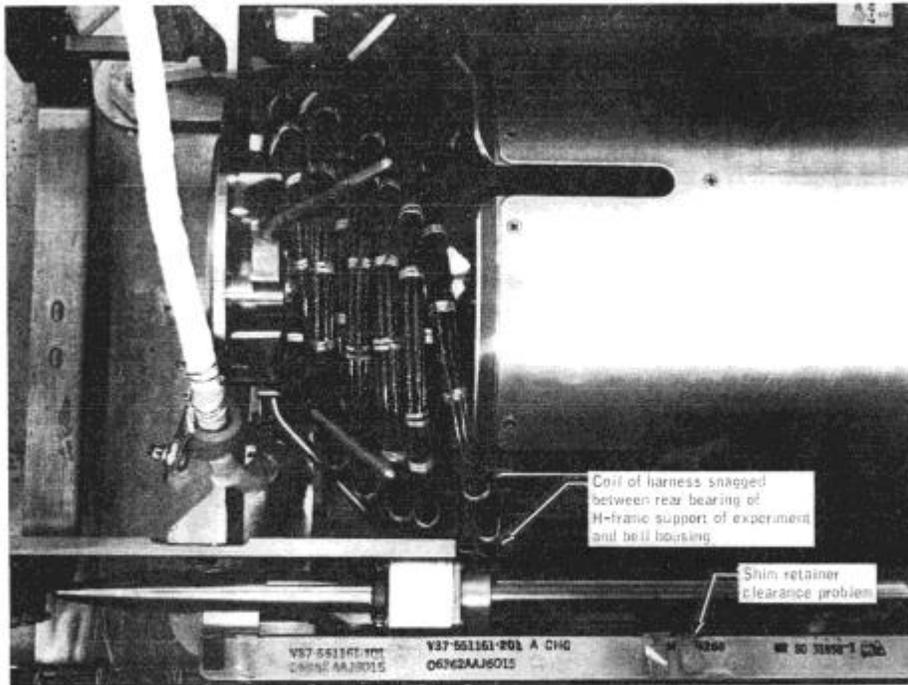
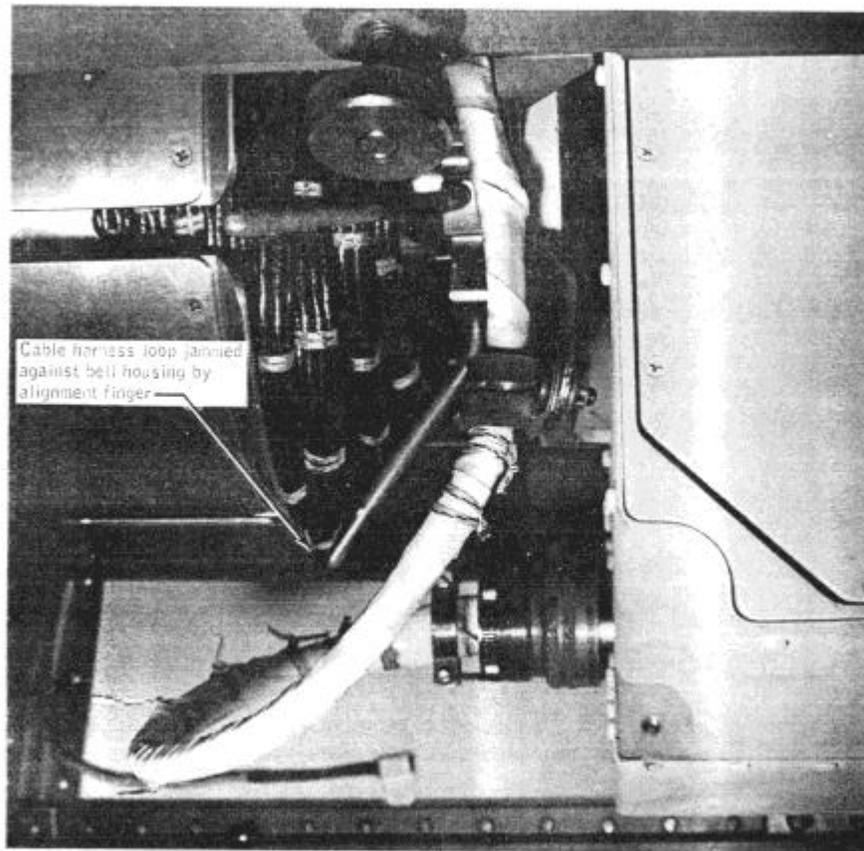
The deploy/retract talkback indicator is normally gray when off, when the boom is fully retracted, or when it is fully extended. The indicator is barberpole when the boom is extending or retracting, and will show half barberpole if the drive motor stalls. The crew noted this last condition on the incomplete retractions.

An inflight test of the Apollo 15 boom indicated that the problem was a function of temperature. Testing and examination of the Apollo 16 spacecraft showed that the failure was possibly caused by pinching of the cable harness during the last several inches of boom retraction. The cable could have been pinched between the bell housing and rear H-frame bearing (**Fig. 14-7**), or a cable harness loop was jammed by a boom alignment finger against the bell housing (**Fig. 14-8**).

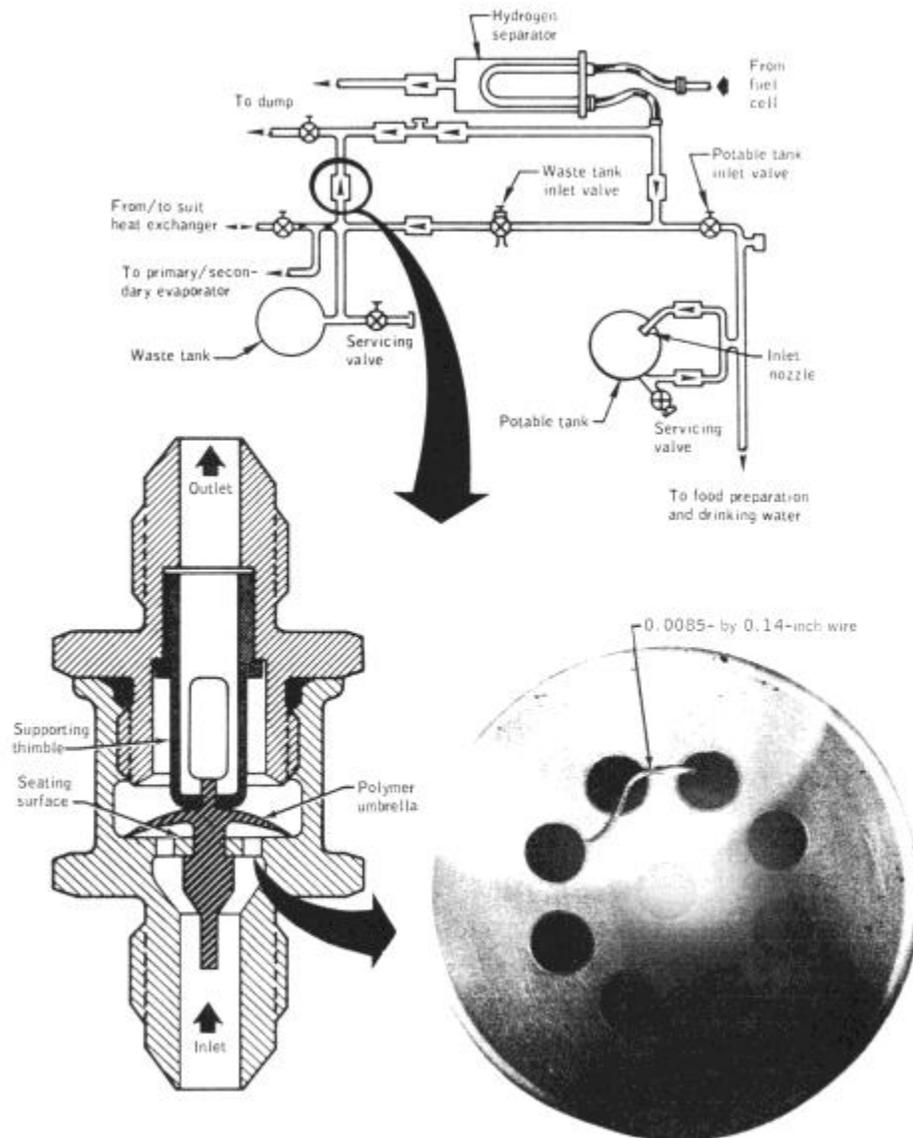
Figure 14-9.- Water management system and failed check valve details.

The check valve between the fuel cell and waste tank dump leg (**Fig. 14-9**) was tested and found to leak excessively. A tear-down analysis of the check valve was performed and a piece of 300-series stainless steel wire (approximately 0.0085 by 0.14 inch) was found between the umbrella and the seating surface (**Fig. 14-9**). This contaminant could cause the umbrella to leak and yet move around sufficiently to allow adequate seating at other times. The wire most probably came from a welder's cleaning brush and was introduced into the system during buildup. Safety wires and tag wires are of a larger diameter than the one found. The check valve at the potable water tank inlet is of a different configuration and is spring loaded closed. The 1-psi pressure required to open this valve is a large pressure drop compared to the other components at the low flow of 1-1/2 lb/hour, and would, therefore, cause the water to flow to the waste tank.

The potable water tank inlet check valve was found to be contaminated with aluminum hydroxide, a corrosion product, of aluminum and the buffer. The potable water tank inlet nozzle was clean and free of corrosion. The check valve corrosion is not believed to have caused the problem, but could have contributed by increasing the crack pressure of the valve.

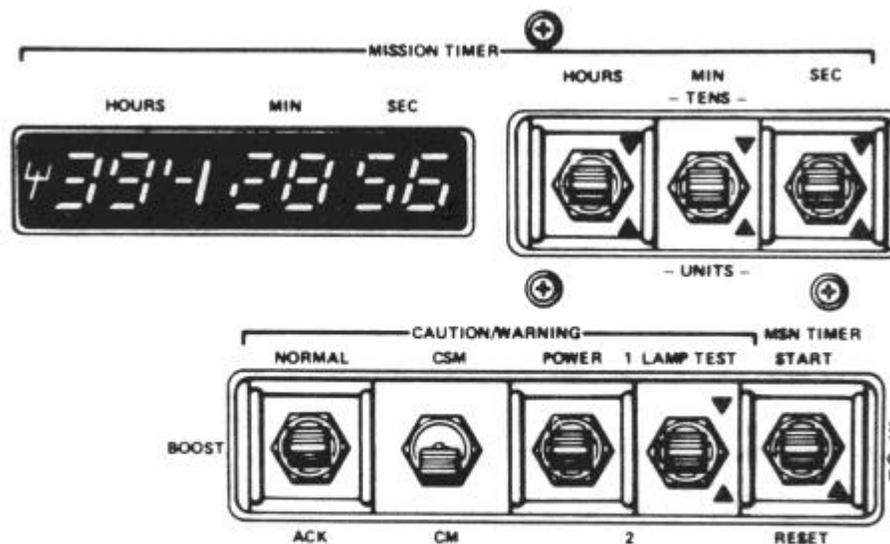
Figure 14-10.- Mission timer.

The panel 2 mission timer stopped at 124:47:37. Several attempts to start the clock by cycling the start /stop/reset switch from the stop to the start position failed (**Fig. 14-10**). The timer was reset to 124:59:00 using the hours, minutes, and seconds switches, and the timer again failed to start when the switch was cycled. The switch was then placed in the reset position. The timer reset to all zeros and started to count when the switch was placed in the start position. The timer was then set to the proper mission time using the hours, minutes, and seconds switches and operated properly for the remainder of the mission.

The timer and all associated equipment were still operating properly after the flight. Thermal , vacuum, and acceptance tests were performed and the cause of the failure could not be determined. Circuit analysis showed that the problem could be caused by one of five integrated circuits on the mounting board circuitry. These suspect components were removed and tested with negative results.

The failure was most probably caused by an intermittent problem within a component which later cured itself. If the problem occurs on a future mission and the timer will not restart, mission time can be obtained from the other timer in the command module, or from mission control. The failure would be a nuisance to the crew.

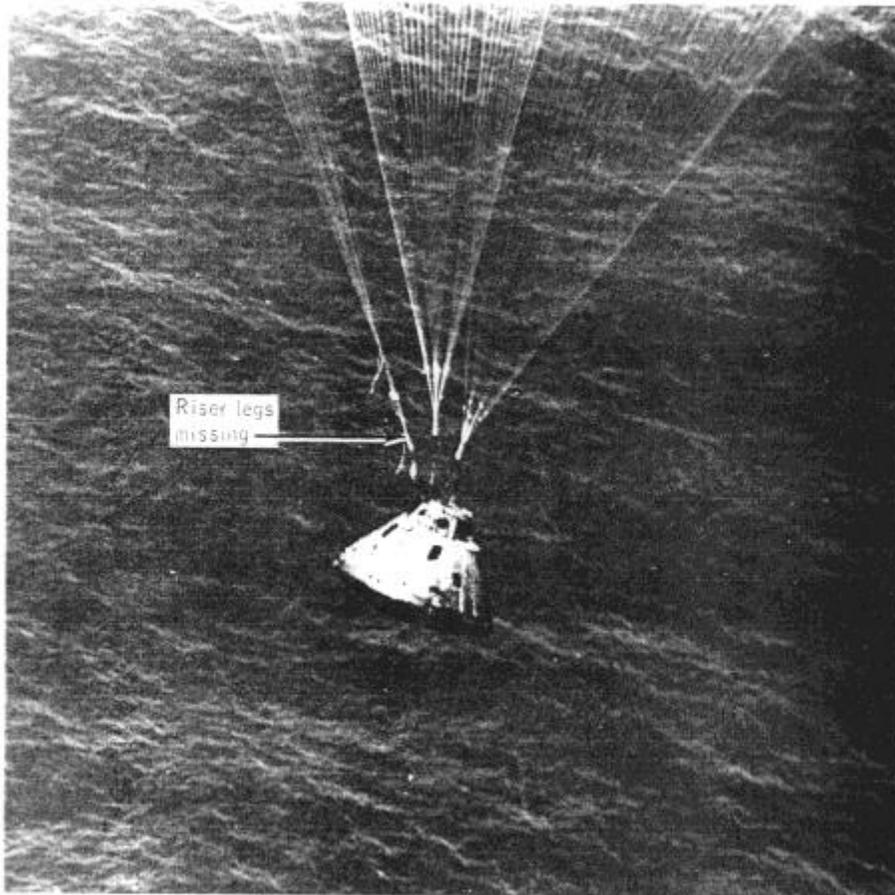
Figure 14-11.- Parachute riser damage noted during final descent.

One of the three main parachutes was deflated to approximately one fifth of its full diameter at about 6000 feet altitude. The command module descended in this configuration to landing. All three parachutes were disconnected and one good main parachute was recovered. Photographs of the descending spacecraft indicate that two or three of the six riser legs on the failed parachute were missing (**Fig. 14-11**).

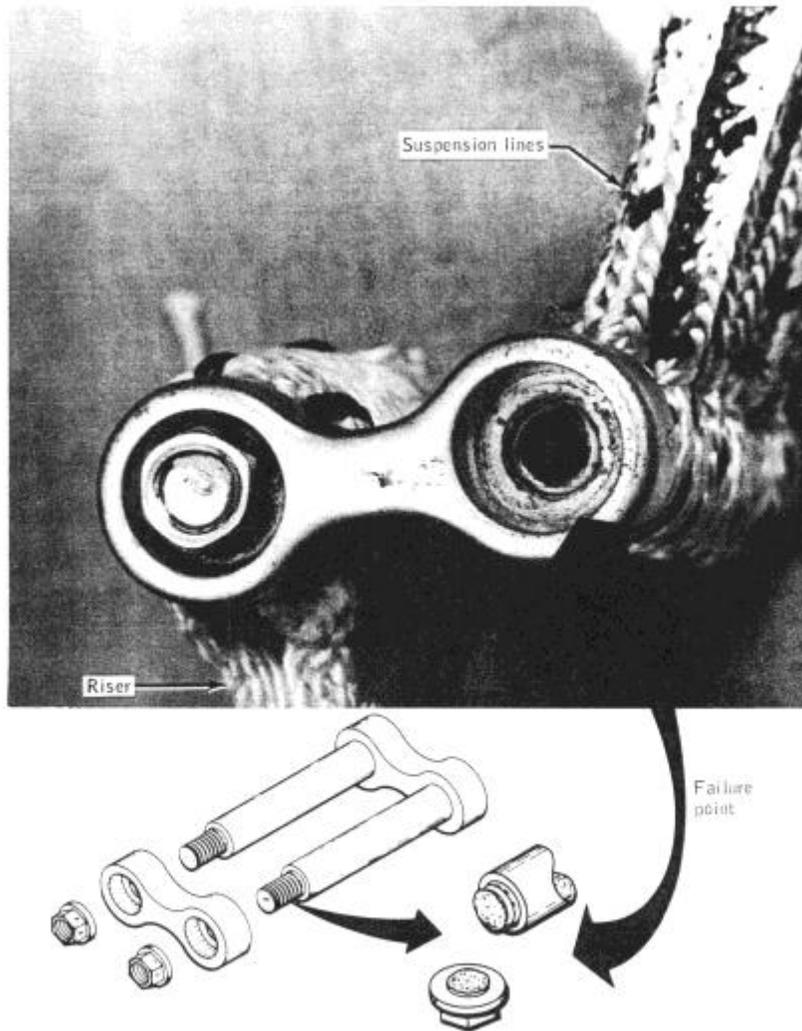
Figure 14-12.- Main parachute connector link failure.

A broken riser/suspension line connector link which was found on the recovered parachute (**Fig. 14-12**).

Onboard and photographic data indicate that the forward heat shield - was about 720 feet below the spacecraft at the time of the failure. The failed link on the recovered parachute implies the possibility of a similar occurrence on the failed parachute. Based on parachute tow tests, however, more than one link would have had to fail to duplicate the flight problem. The two possible causes have been identified as hydrogen embrittlement or stress corrosion.

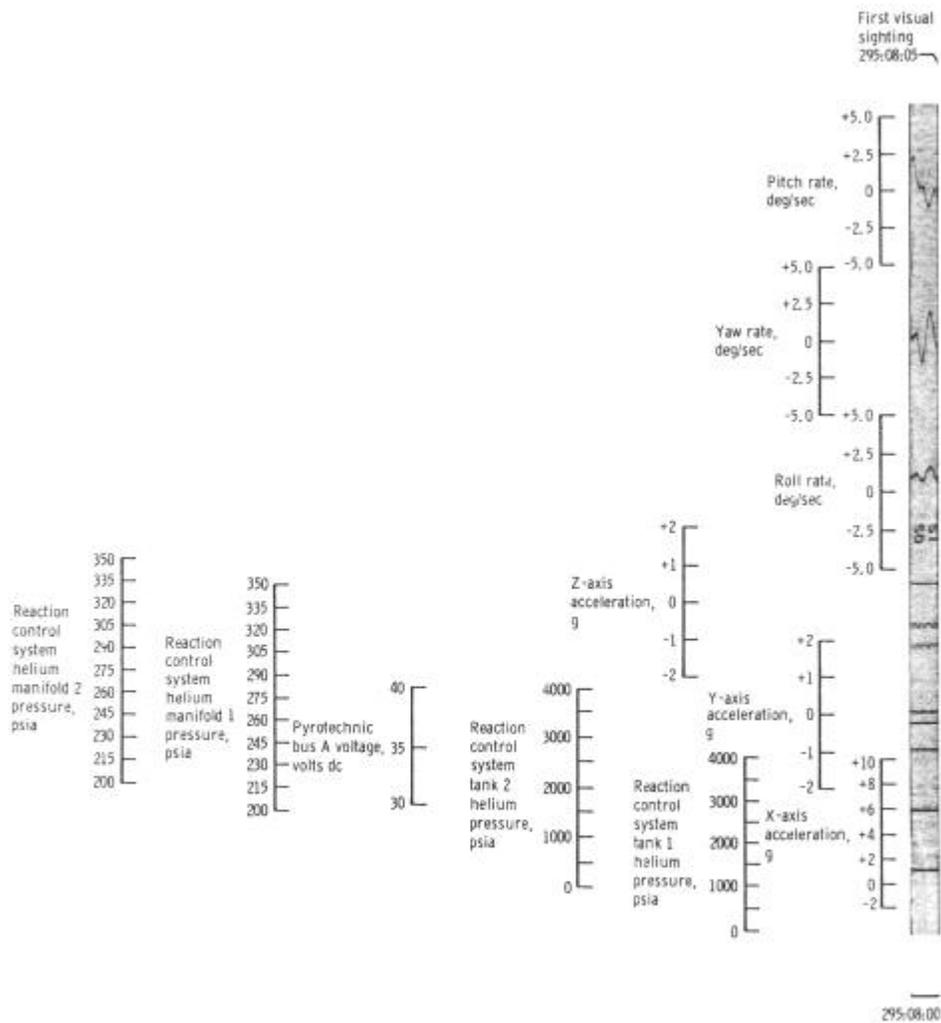
Figure 14-13.- Sequence of events during descent on the main parachutes.

The command module reaction control system depletion firing was considered as a possible candidate because of the known susceptibility of the parachute material (nylon) to damage from the oxidizer. Also because the oxidizer depletion occurred about 3 seconds prior to the anomaly, and fuel was being expelled at the time the anomaly

occurred (Fig. 14-13). Further, the orientation of the main parachutes over the command module placed the failed parachute in close proximity to the reaction control system roll engines. Testing of a command module reaction control system engine simulating the fuel (monomethyl hydrazine) dump mode through a hot engine resulted in the fuel burning profusely; therefore, the fuel dump is considered to be the most likely cause of the anomaly.
